Survey and Evaluation of Fine Bubble Dome Diffuser Aeration Equipment

EPA-600/2-81-222
September 1981

Daniel H. Houck
Association of Metropolitan Sewerage Agencies
Washington, D.C. 20036

Arthur G. Boon
British Water Research Centre
Stevenage, England SG1 1TH

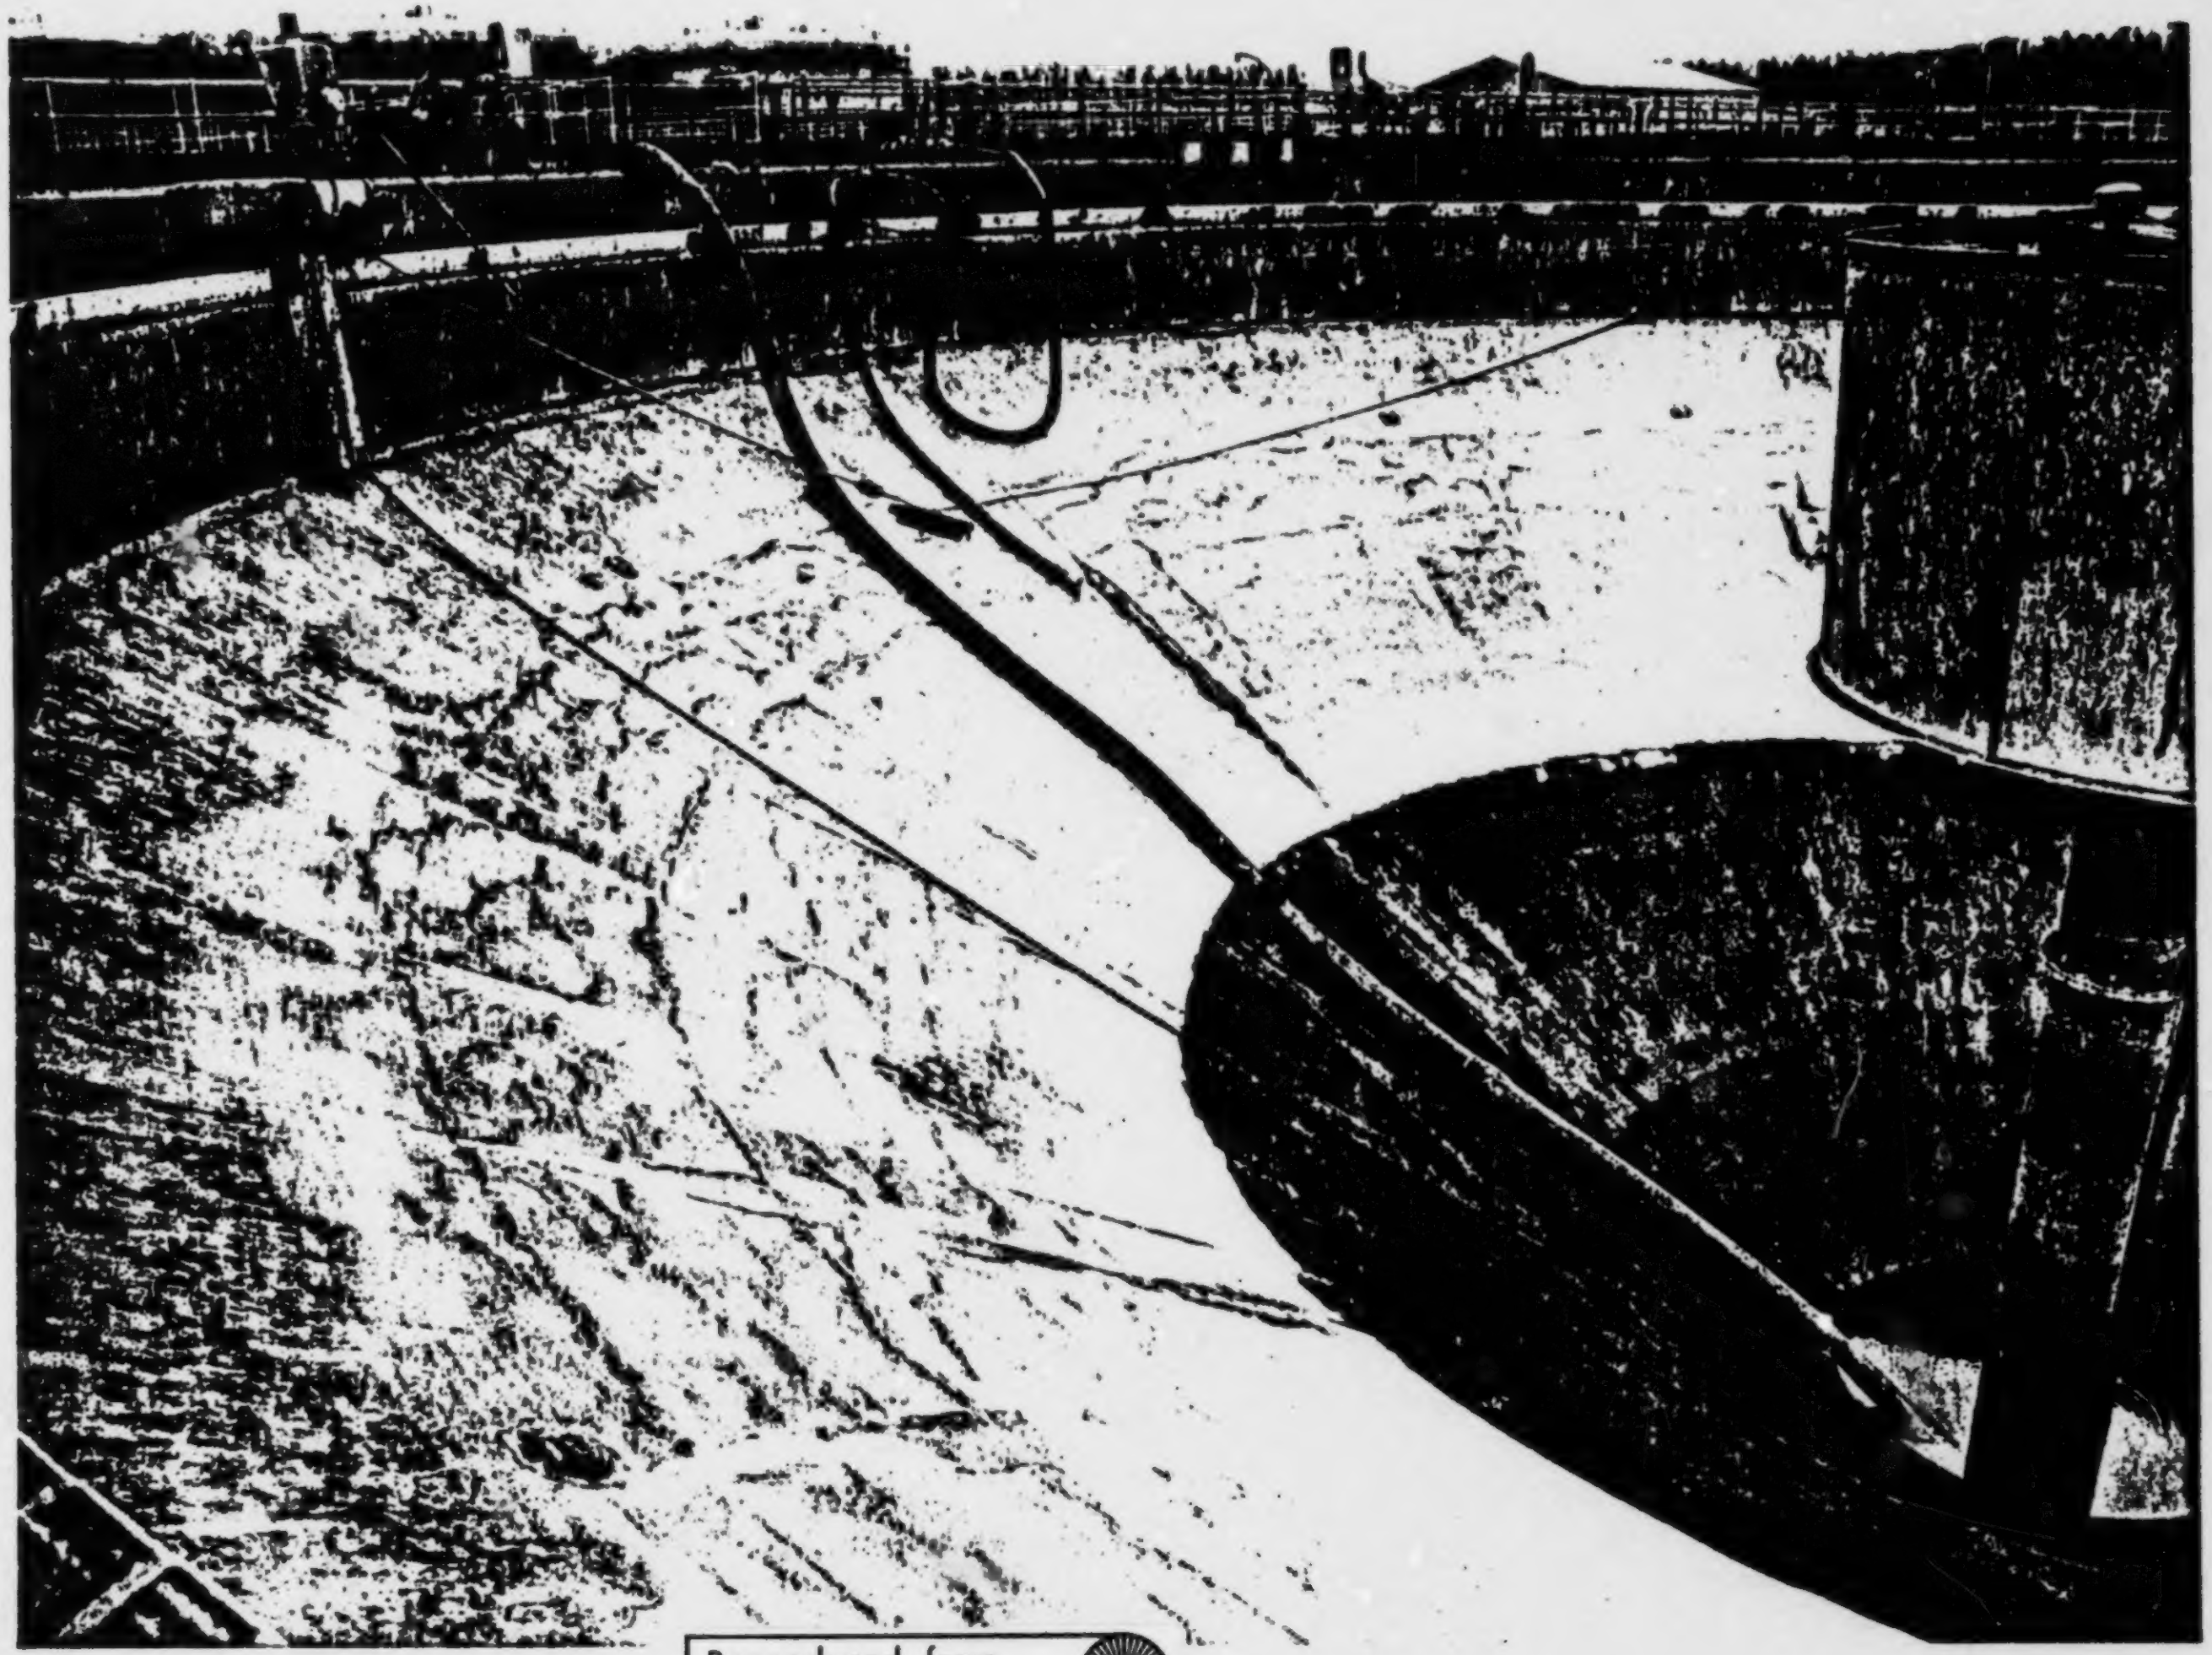
Figure 2. U.K. thickener-style secondary clarifier.

Also of interest is the thickener style of design applied to most secondary clarifiers. Figure 2 depicts a typical secondary clarifier encountered at most of the plants visited in the United Kingdom. The steep floor slope, normally 30 degrees, greatly facilitates desludging, and the scraper mechanism

Likewise, U.K. secondary clarifier designs were quite conservative and appeared to give plant operators more reserve capability in the event of process upsets and episodes of poor sludge settleability. However, the long detention times used could be a source of problems with sludge blanket denitrification as well, as noted in Section 6. The U.K. design configuration that utilizes steeply sloped floors (30° slope) may merit further attention in the United States in view of the very good operating experience with this simple design (see Figure 2, Section 6).

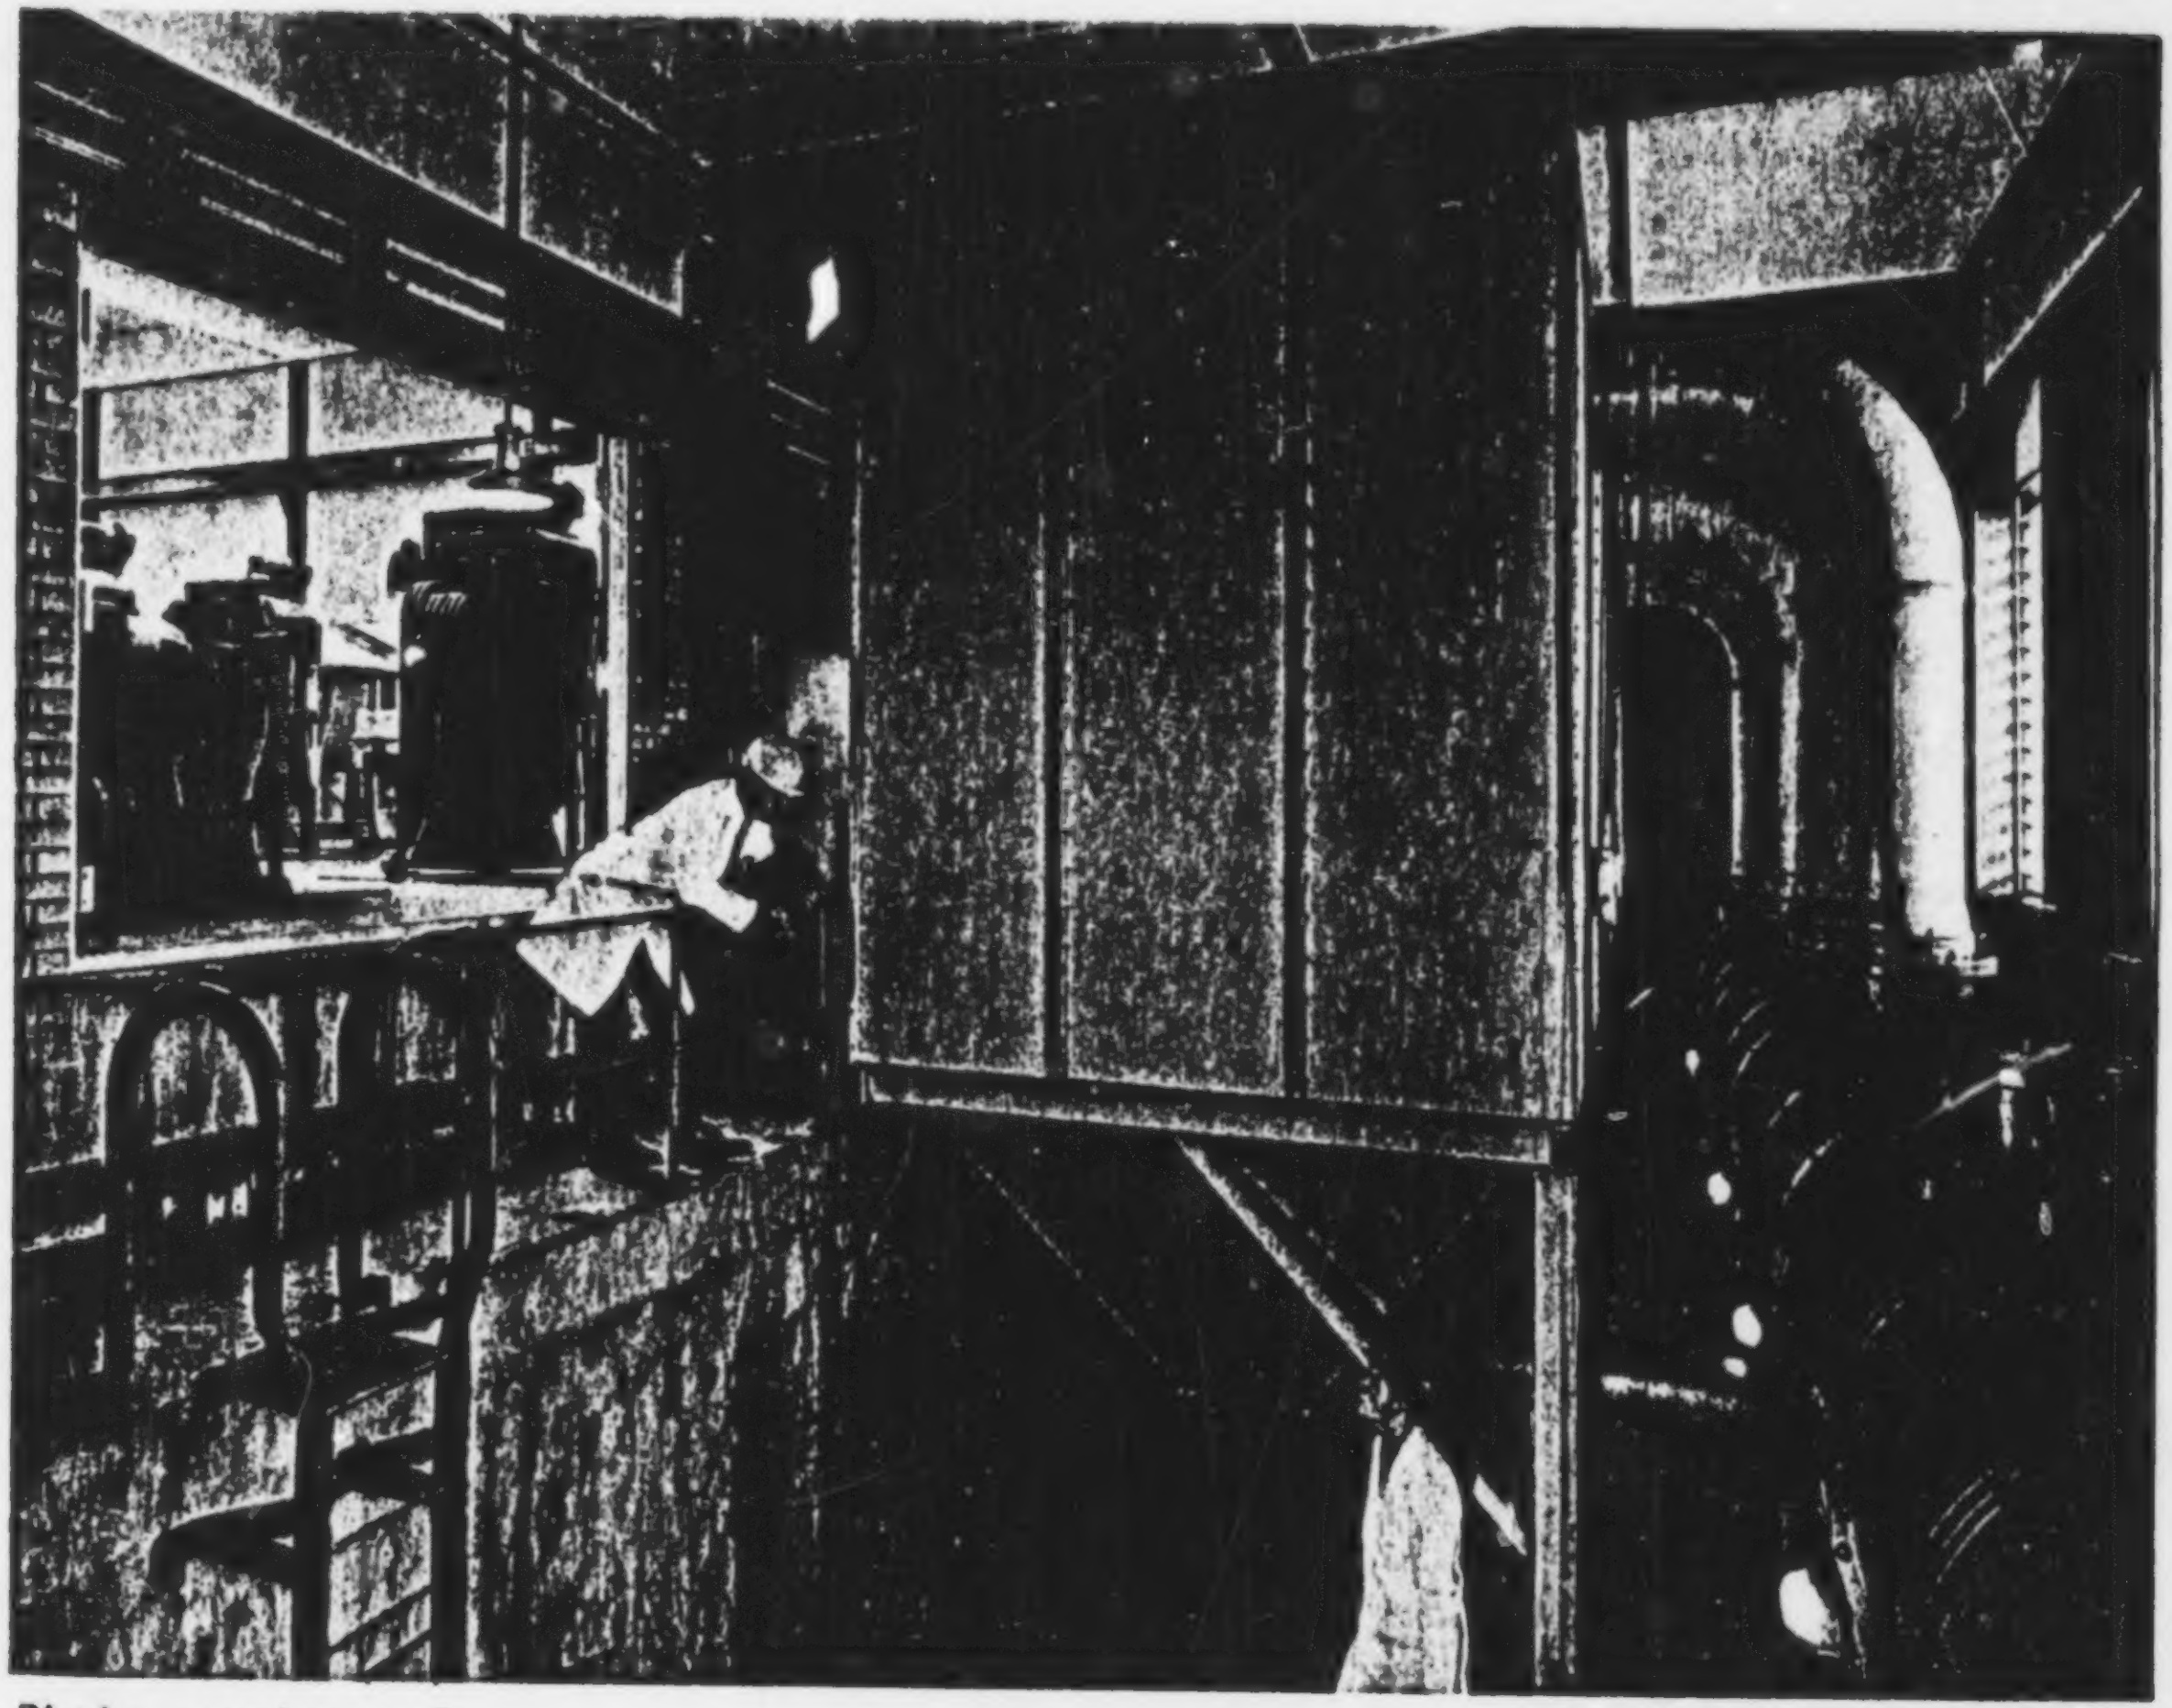
Figure 3. Bag house air filters at Beddington.

The three types of air cleaning equipment encountered included bag house collectors, electrostatic precipitators, and disposable cartridges. Of these, bag house collectors were most commonly used in the U.K. plants visited. The units are constructed as steel enclosures which house sets of cloth stocking tubes that are precoated with filter aid before being placed in service and after each cleaning. Historically, an asbestos-based precoat was used. However, because of health and safety considerations, it is rapidly being supplanted with a cellulose-based precoat. Figure 3 shows three of the large bag house air filters at Beddington. Currently, six units are in service continuously and another one is on standby.

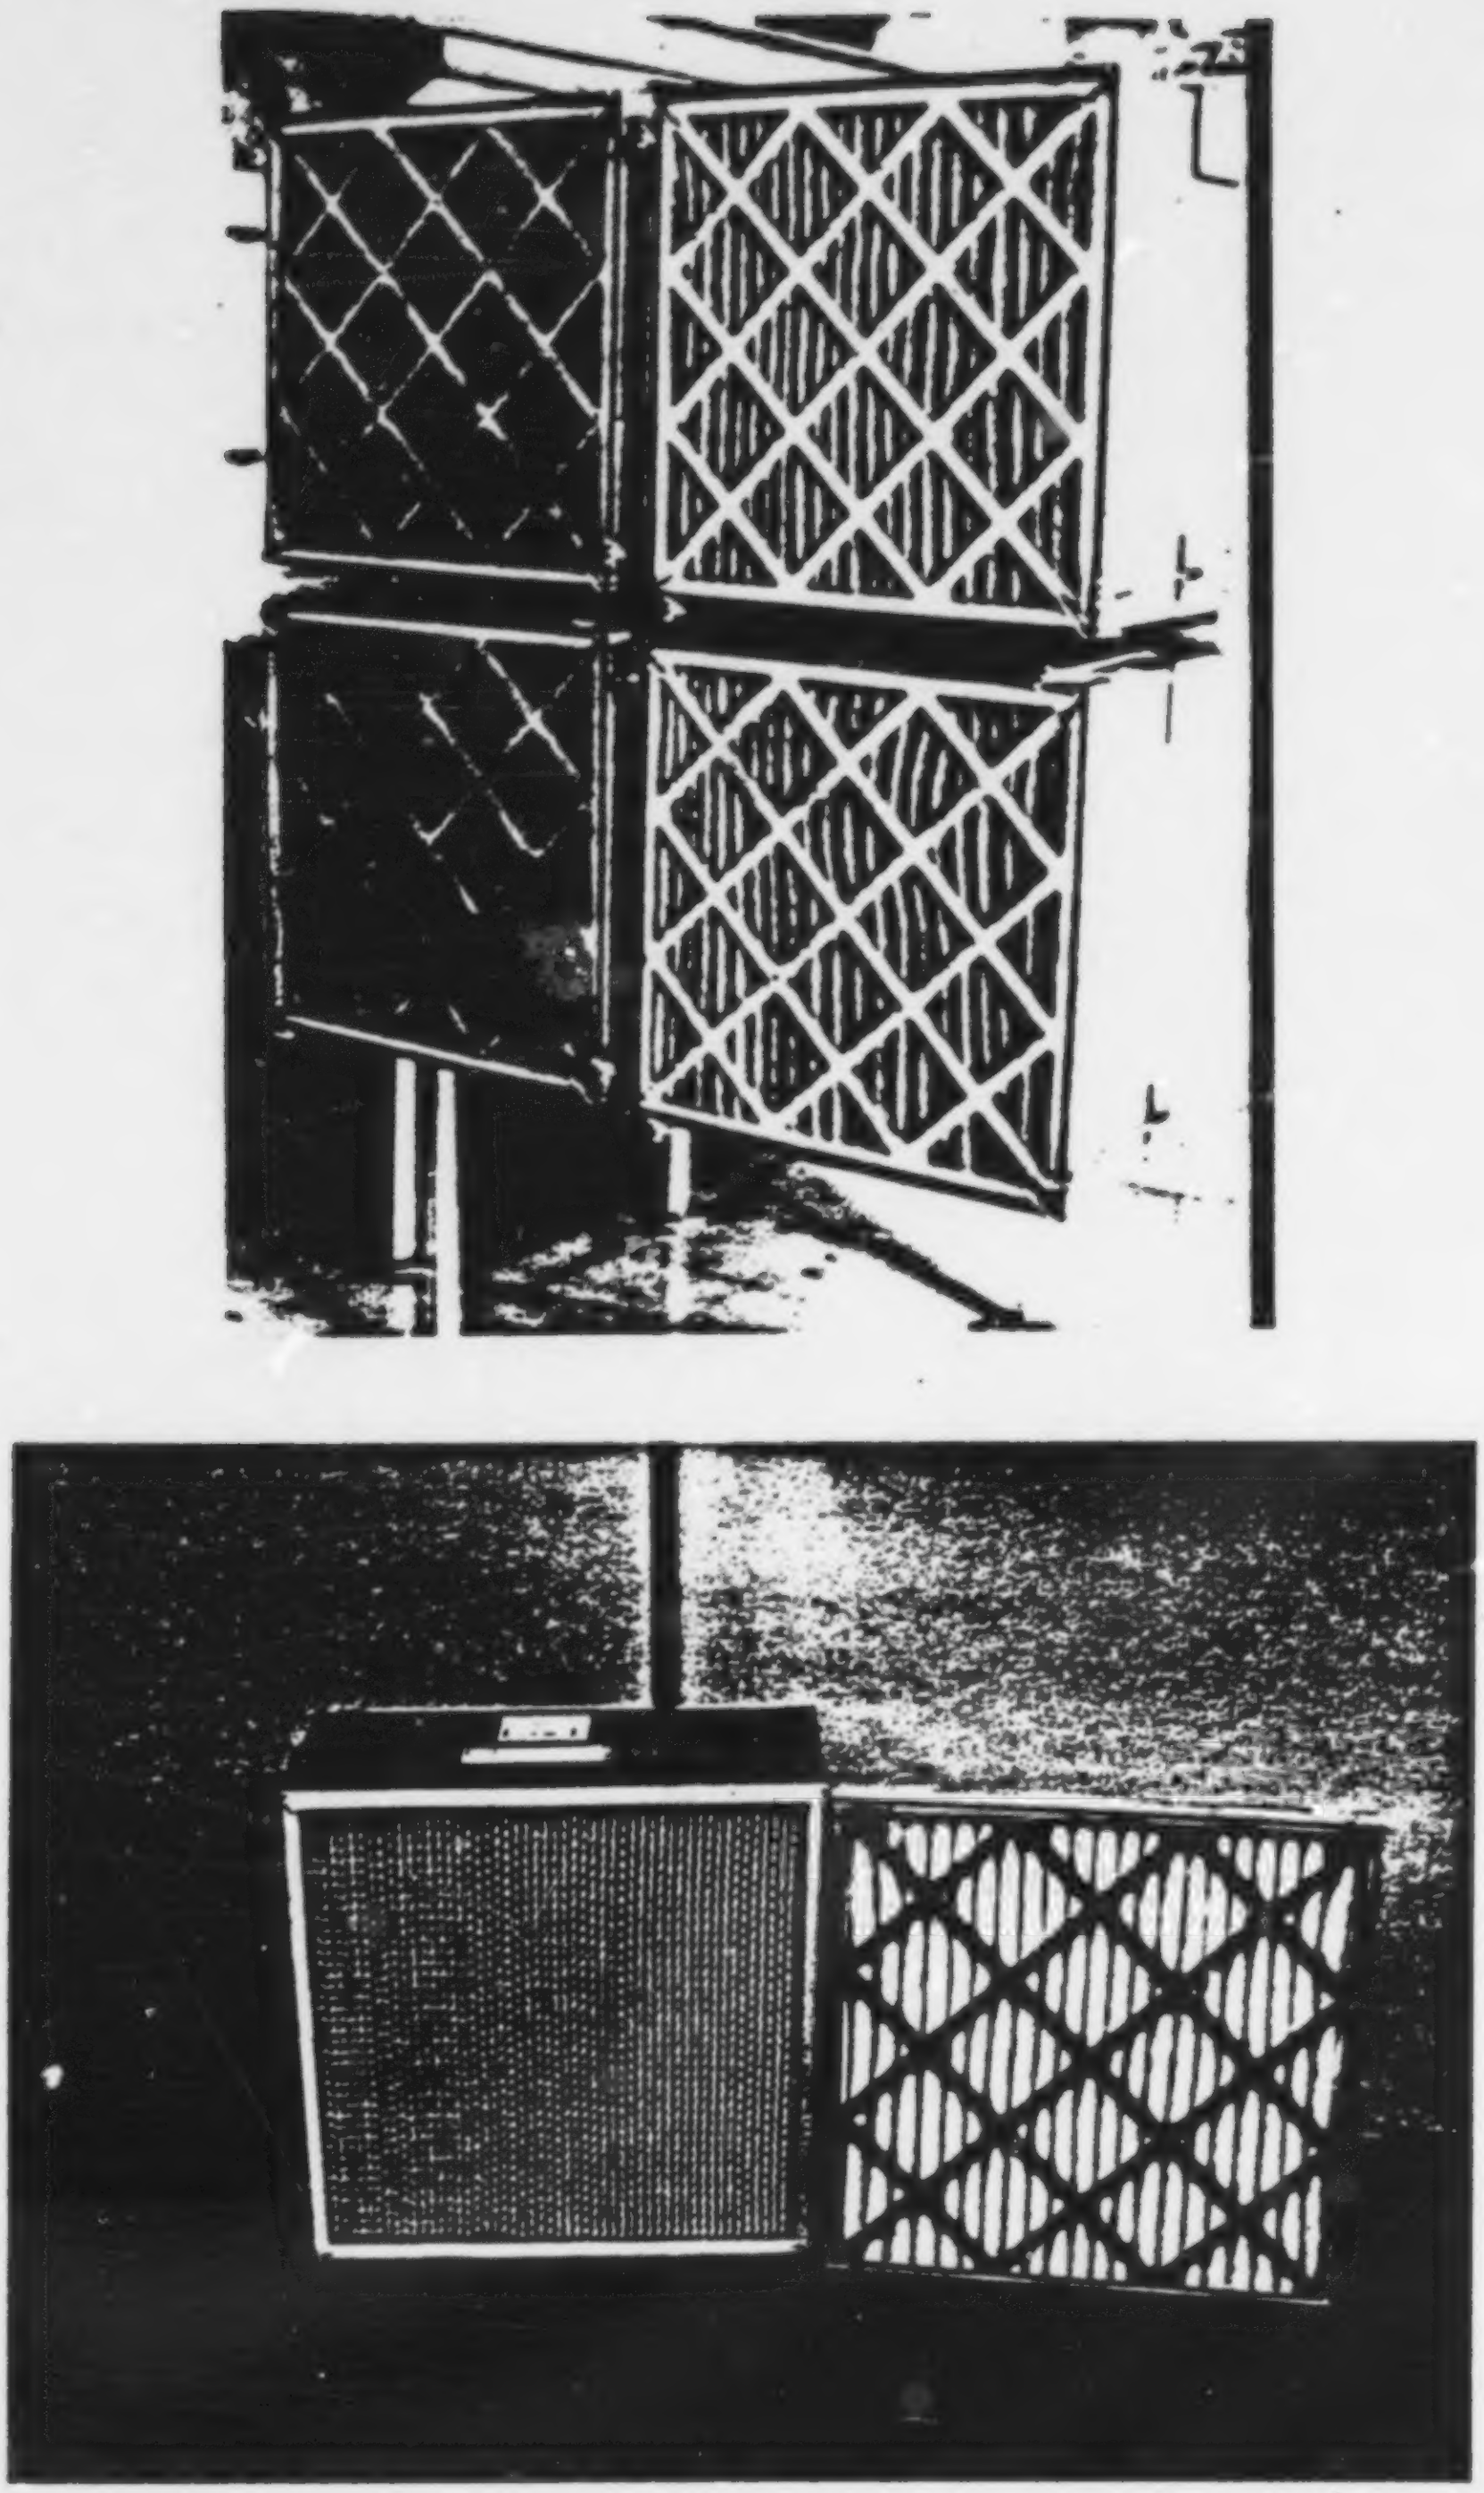
Figure 4. Disposable cartridge filters at Finham.

The size, expense, and precoat requirements of bag filters have diminished their selection for newer plants. Rather, replaceable filters (Figure 4) or electrostatic precipitators (Figure 5) are increasingly the technologies of choice in the newer plants. The precipitators can be installed in a third to half the space required for bag houses and have relatively simple maintenance needs. Simplest of all are the replaceable cartridge filters. As discussed in Section 8, these units are relatively expensive to replace but take up minimal room and require very little maintenance.

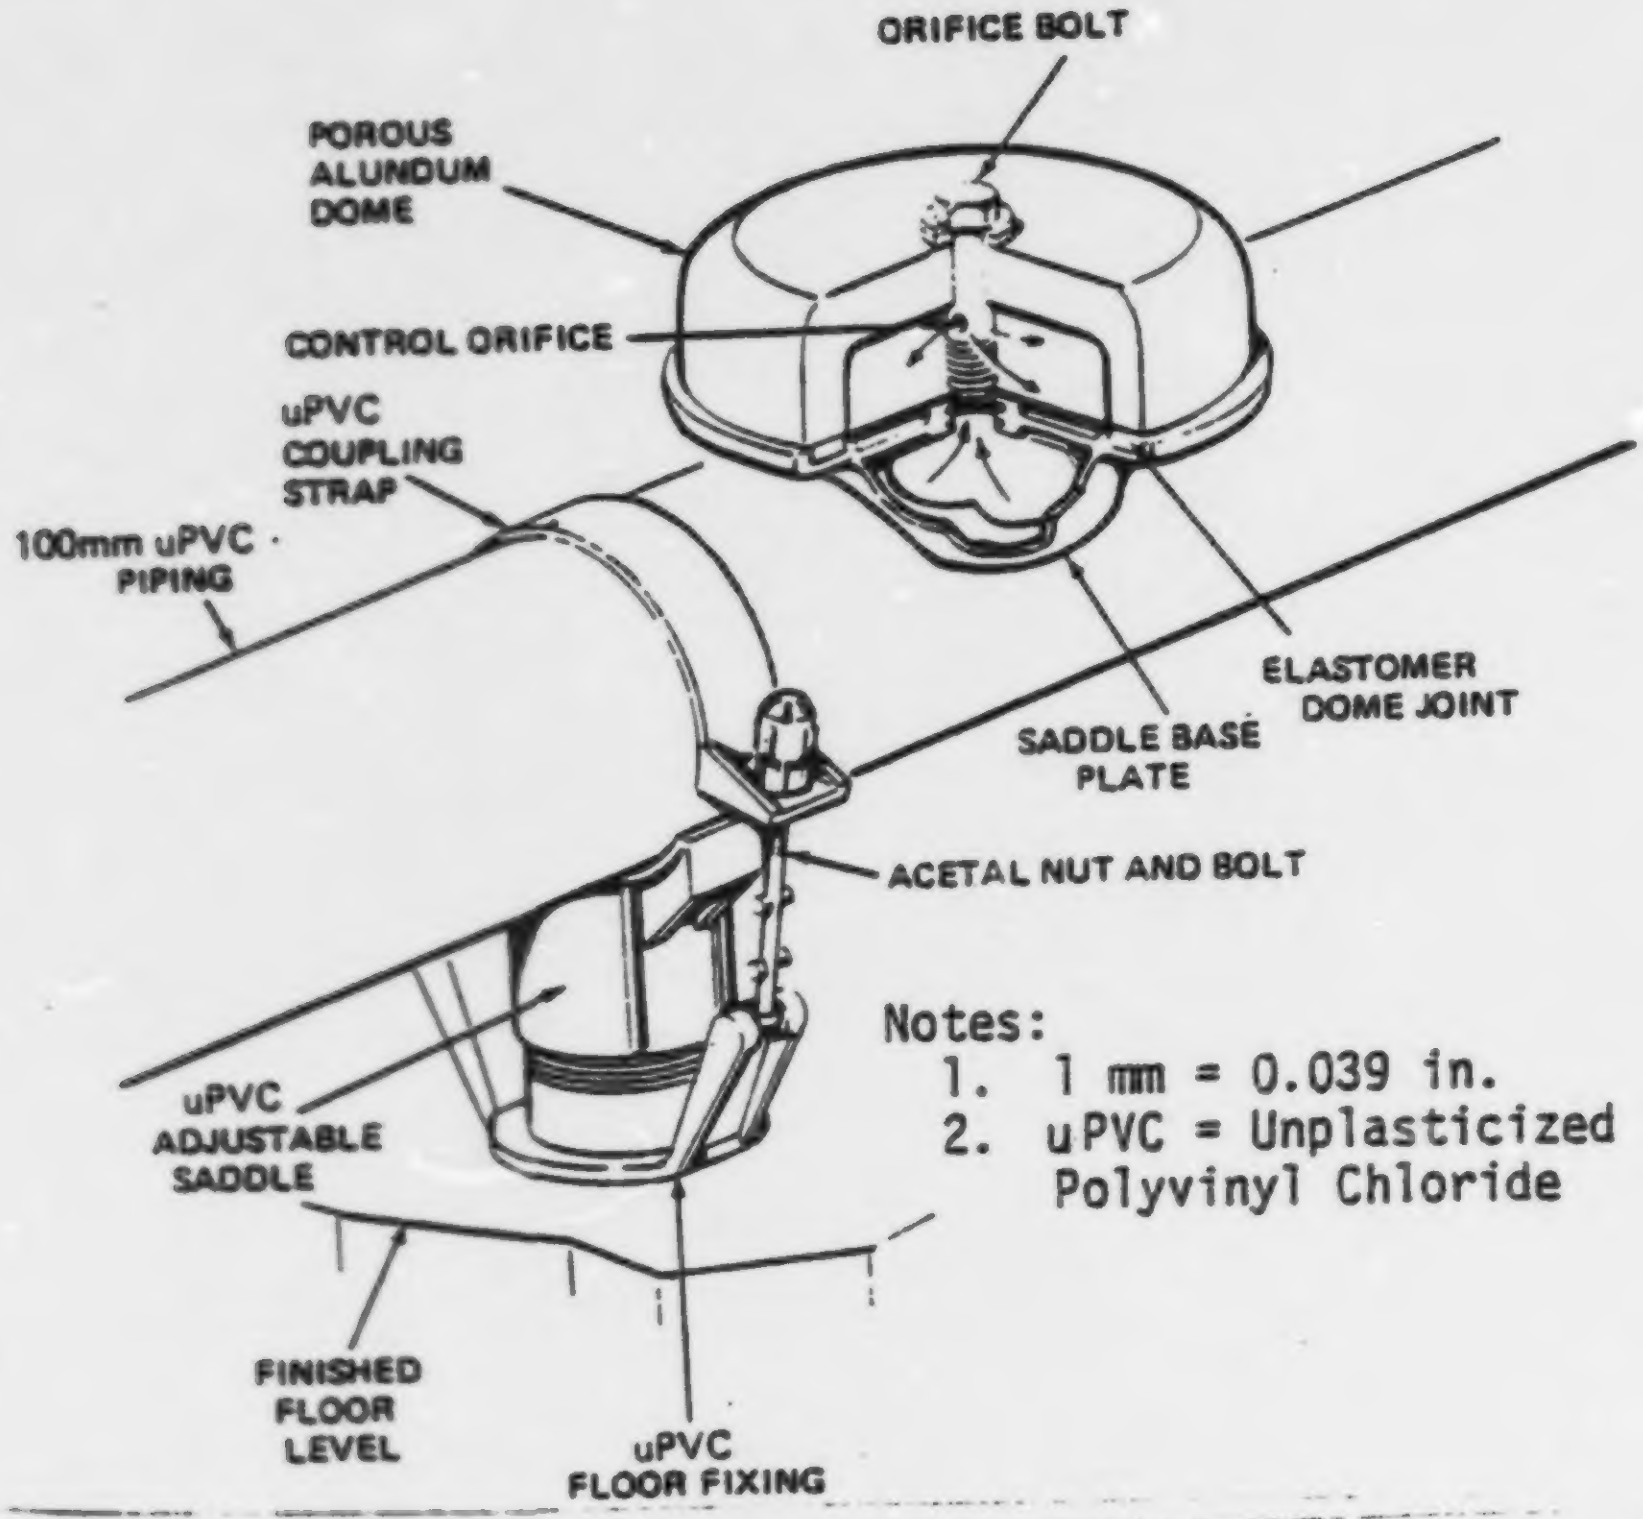
Several plants have also reported scattered failures of other plastic parts, notably the pipe coupling straps and orifice bolts. Beckton had major problems on startup with the coupling straps. Mogden has had considerable problems with failure of the orifice bolts, probably related to over tightening during installation. Most of the plants, however, reported few or no startup problems of this nature. Careful supervision of installation to avoid over tightening of plastic parts was cited as the key to trouble free startup by most of the plant personnel. It was also noted that the plastic parts were much less costly to replace than previously used brass bolts.

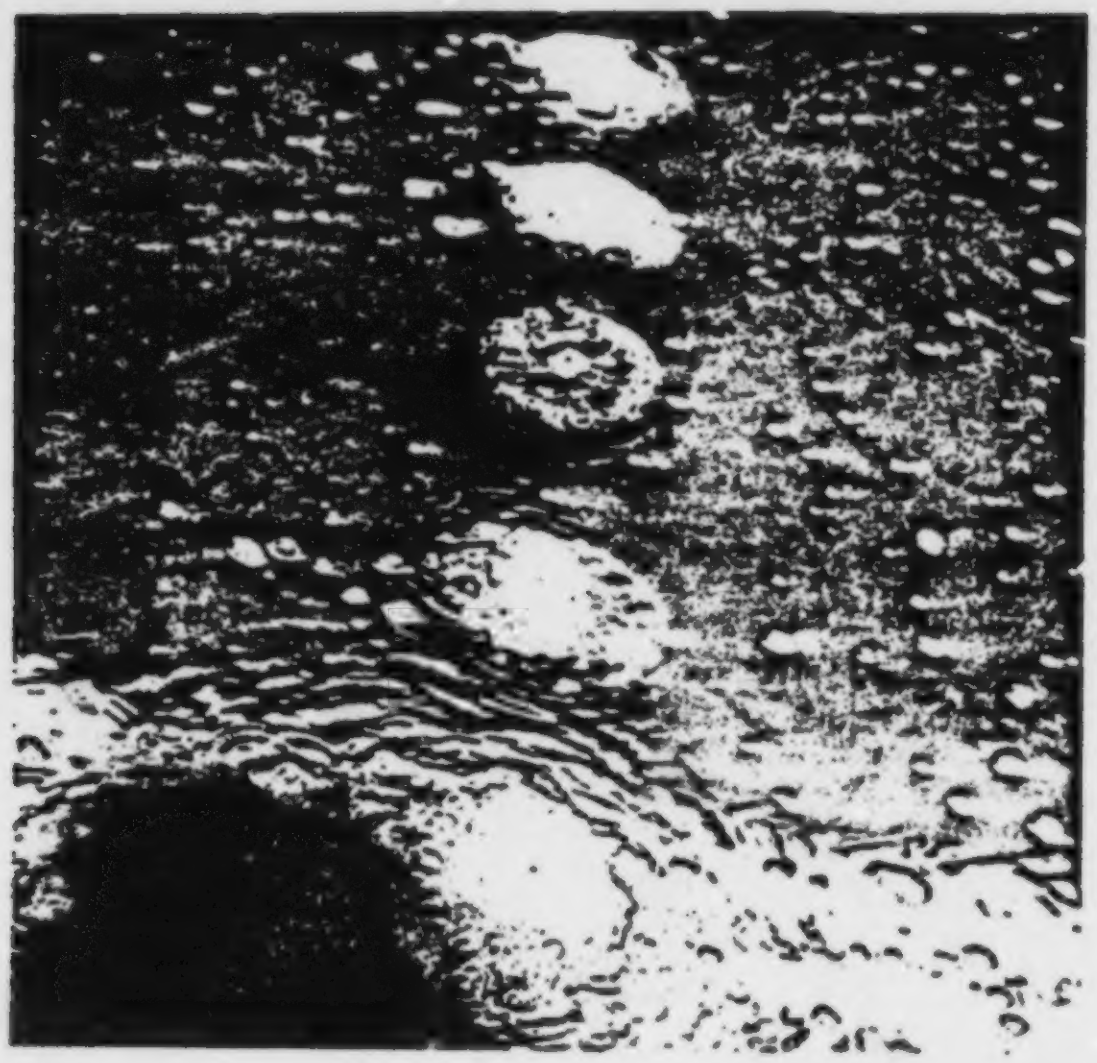
Figure 9. Slime growth on domes at Beddington.

Figure 10. Brushing domes at Beddington.

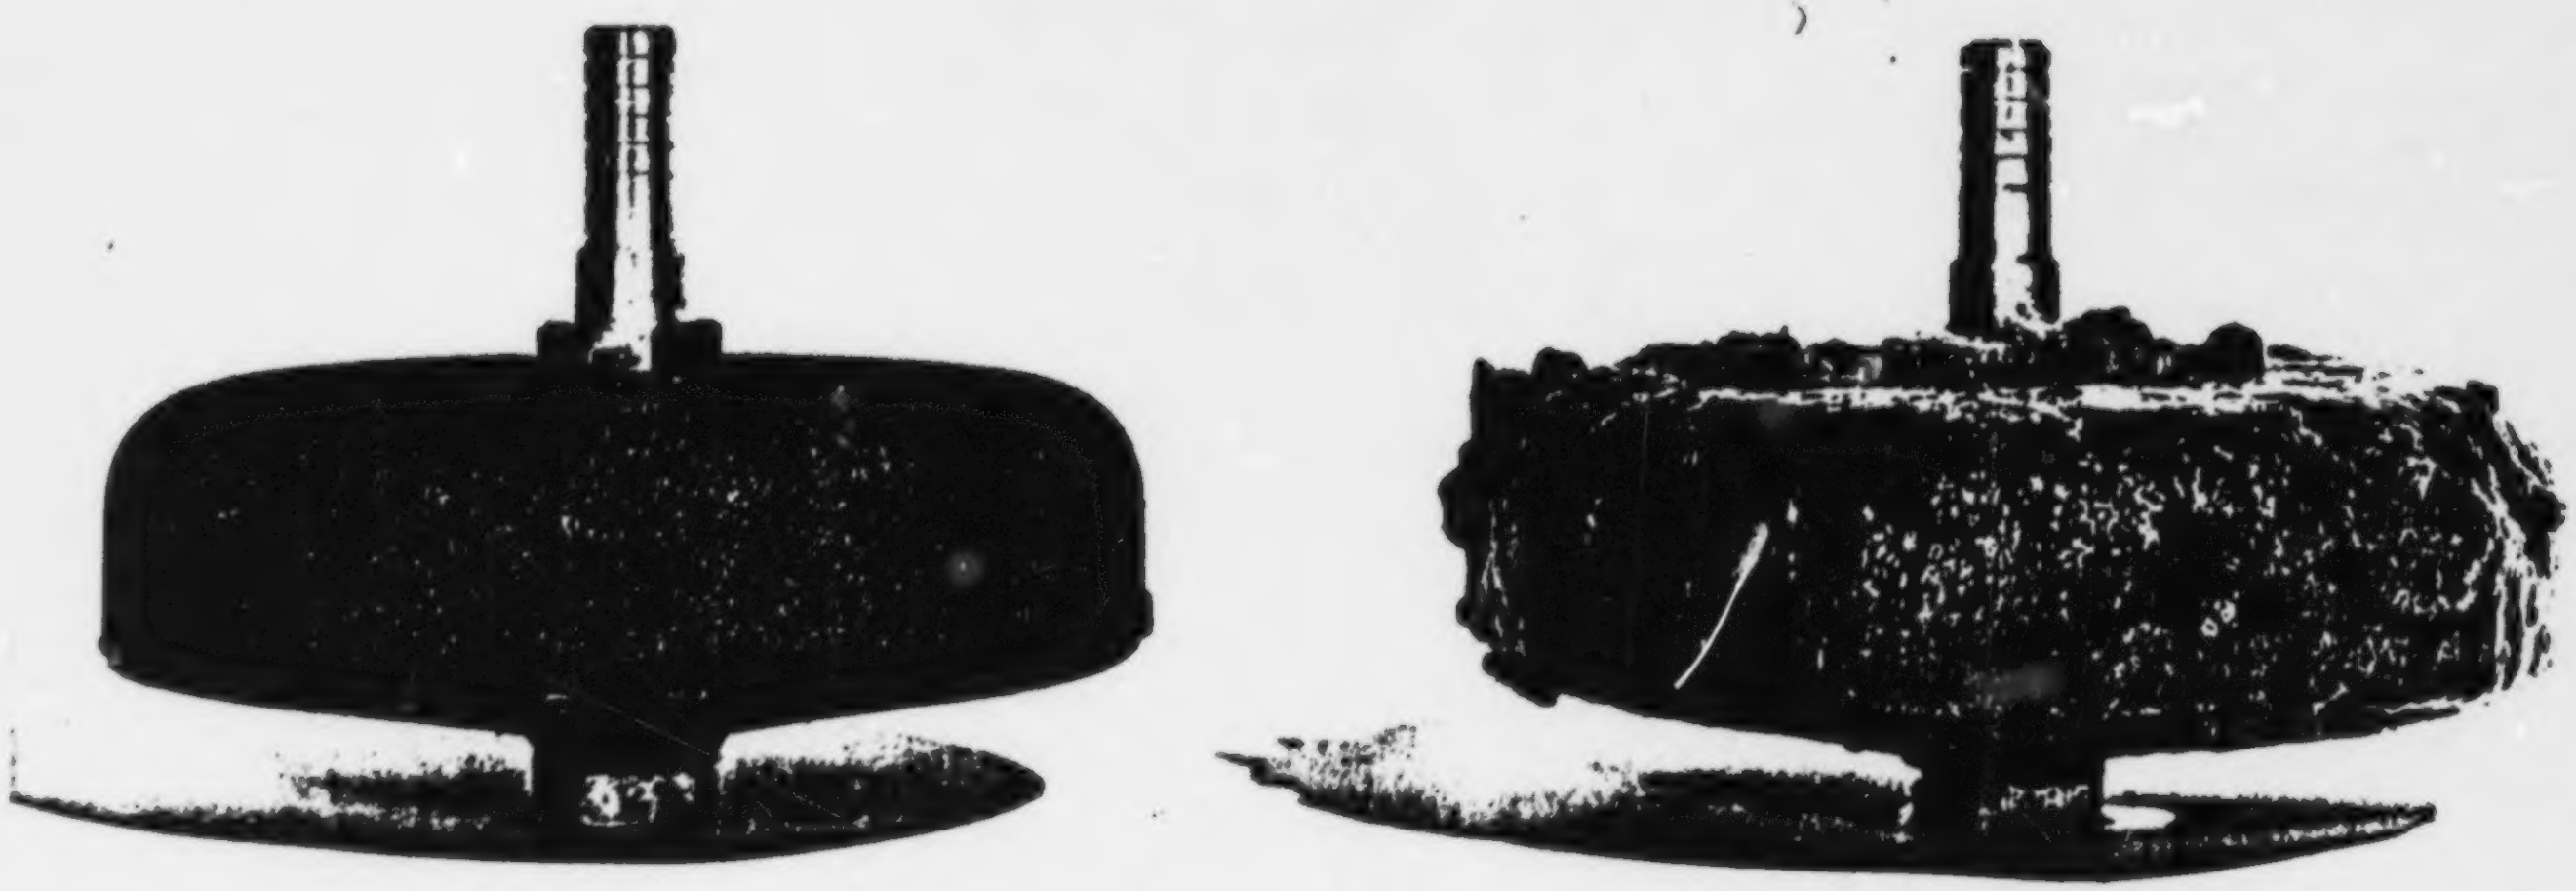
Figure 11. Clean and slimed domes from WRC tests.

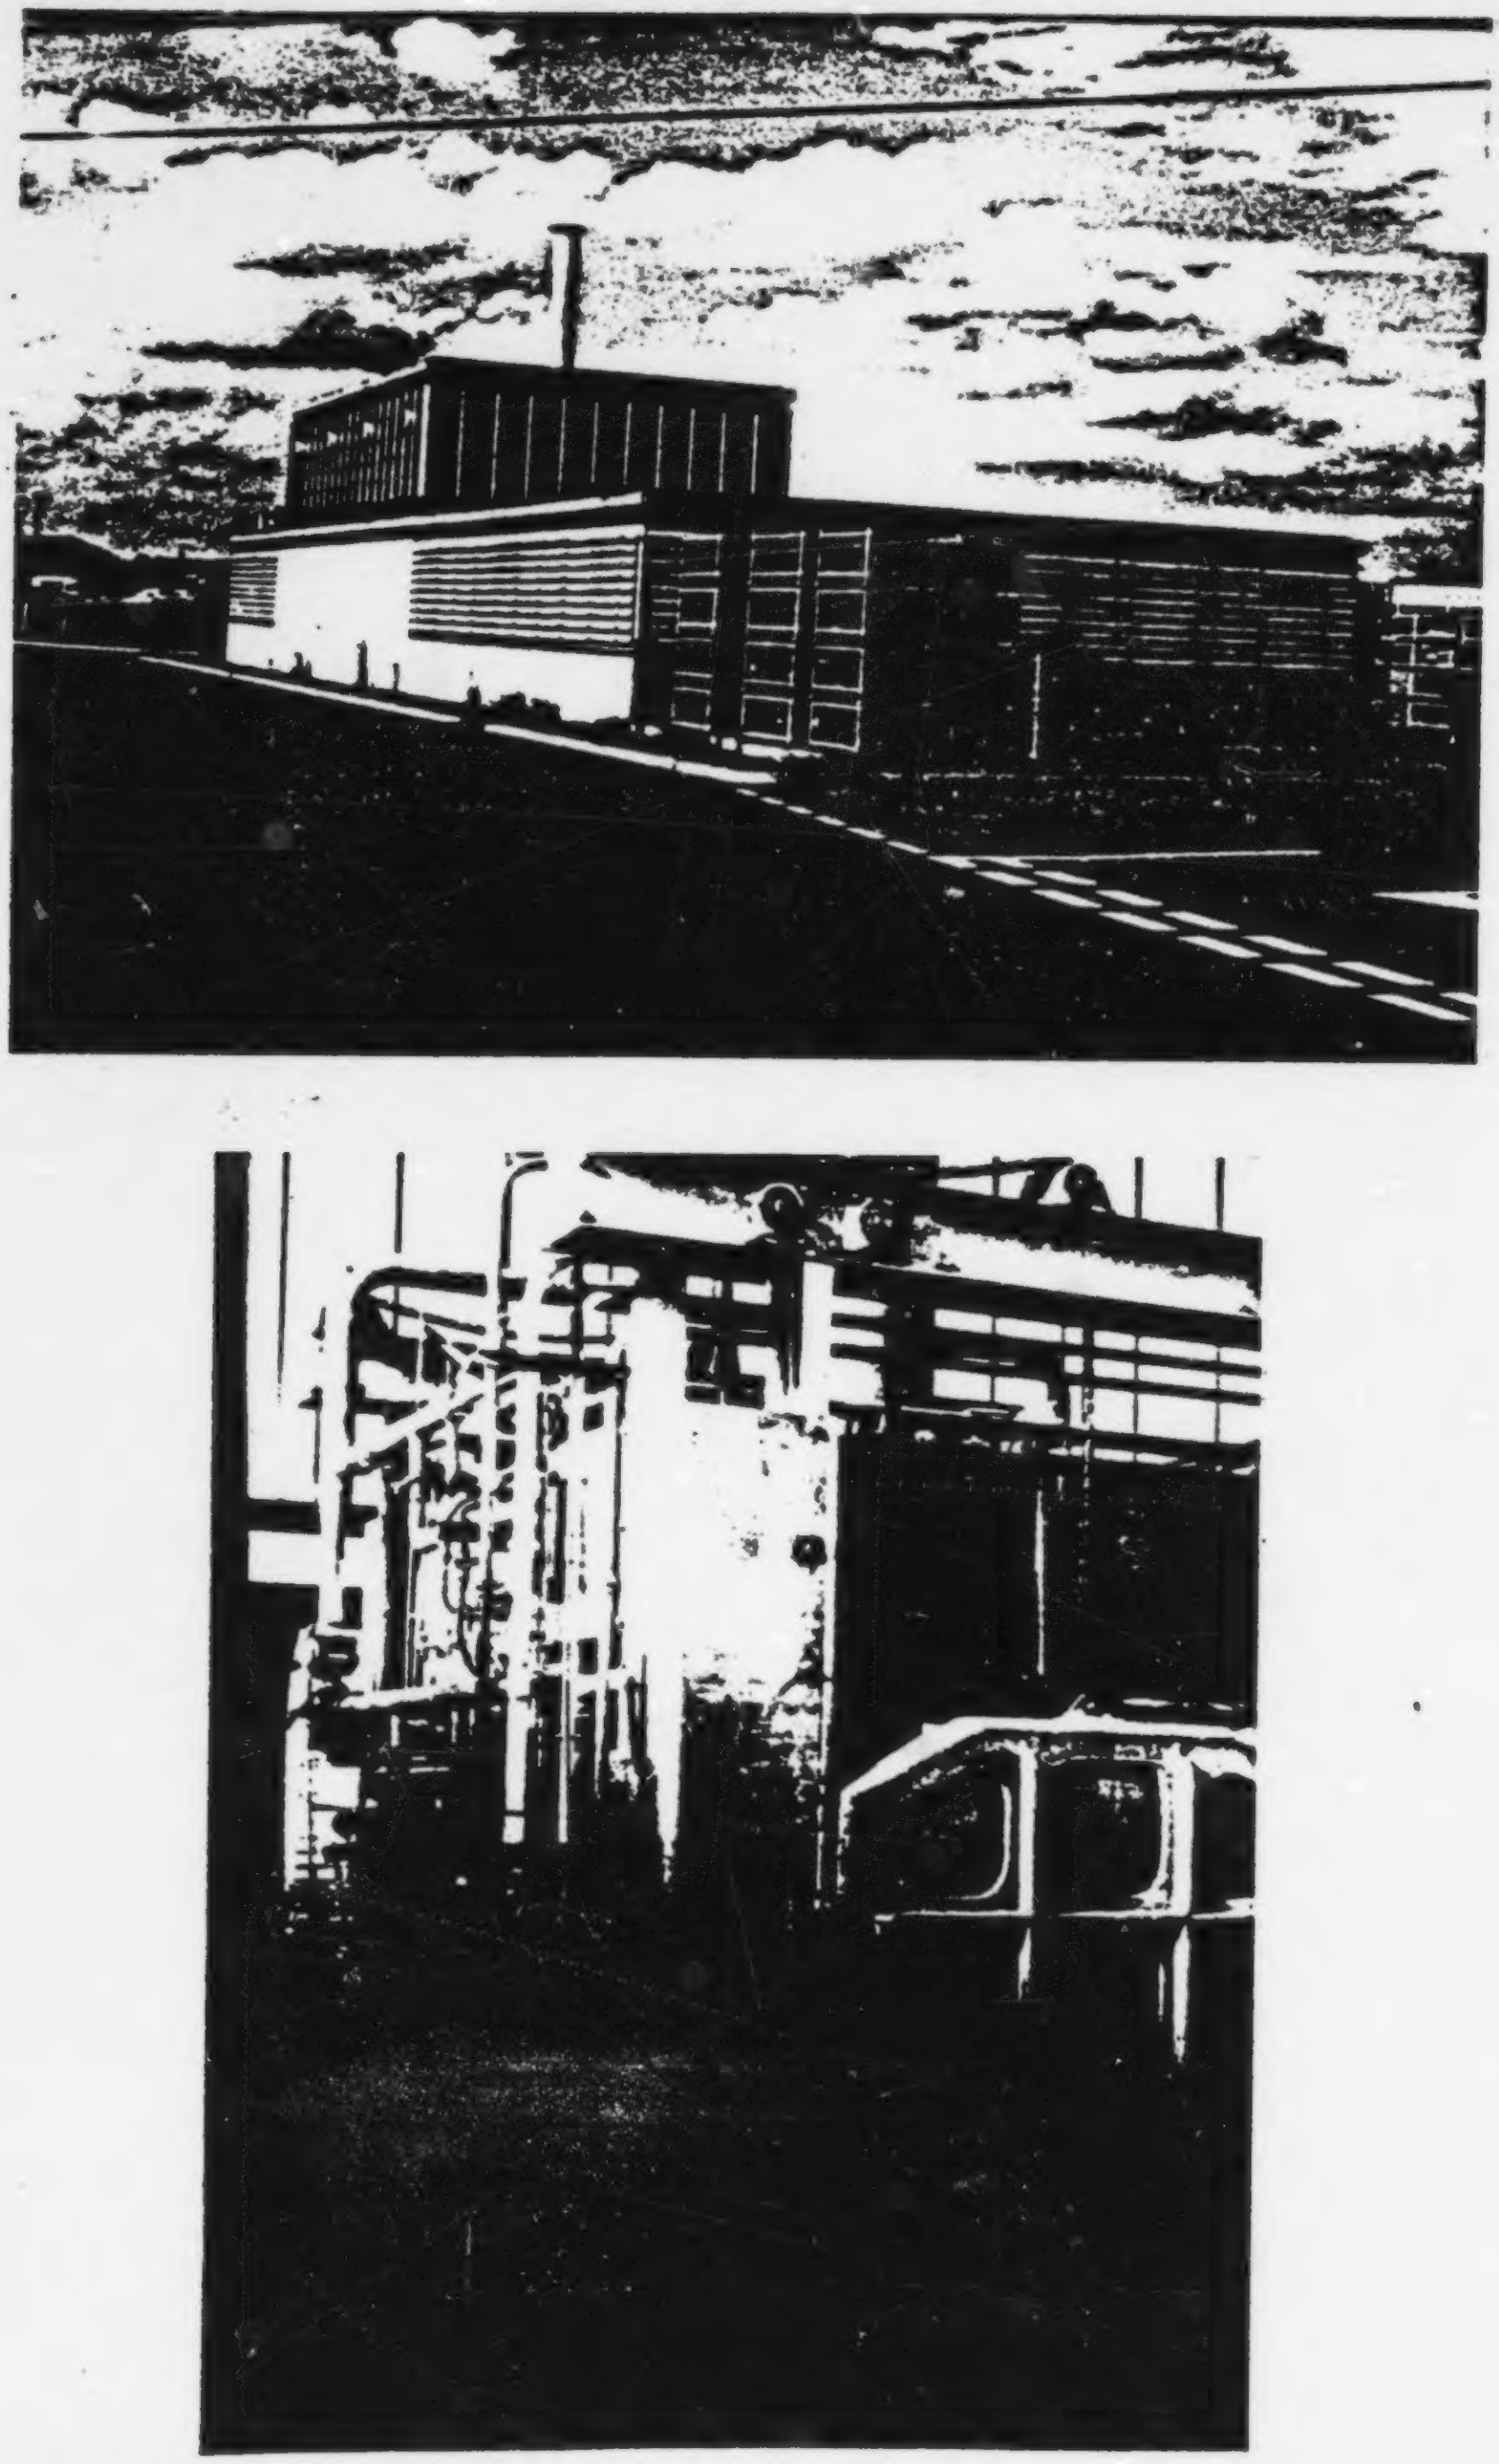
Figure 13. Beckton dome firing facility.

In 1971, a diffuser dome refiring furnace, shown in Figure 13, was constructed at Beckton. The facility has a capacity of 100,000 domes/yr and was designed to service domes from other Thames Water Authority plants as well as Beckton. It was constructed at a cost of £66,130 ($132,260 U.S.) in 1971, and its current estimated replacement cost is three-and-a-half times its initial cost.

Significant labor is involved in loading and unloading the domes, maintaining the furnace, and carrying out the complete dome cleaning cycle.
